AVRO ARROW
quarterly technical report

March 31 1958

ARROW
QUARTERLY TECHNICAL REPORT

70/ENG PUB/6

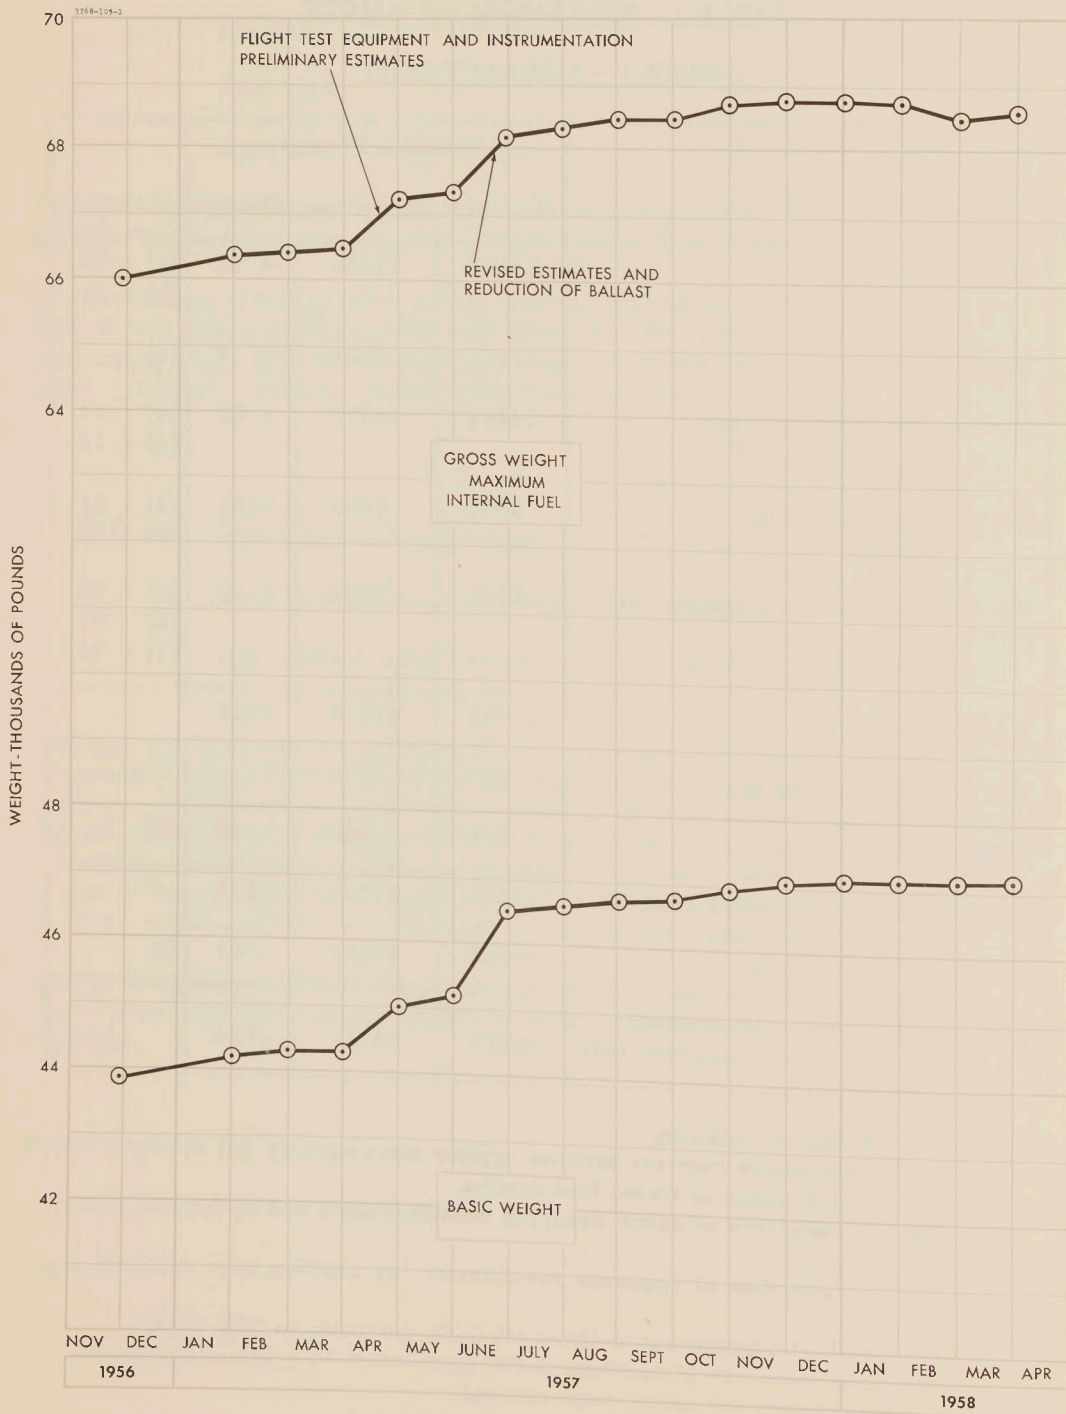
FIG. 3 WEIGHT HISTORY - ARROW 1, AIRCRAFT 25201

The ARROW 1 weight history (Figure 3) and weight summary (Table 1) are applicable to aircraft 25201. Since this aircraft is now actively engaged in a flight testing program, the applicable monthly weight report will be discontinued and will be replaced with periodic weight reports, based on actual weighings of the aircraft.

Based on the data given in Table 1, 815 pounds of nose ballast is required to restrict centre of gravity (C. G.) travel to the extreme aft position of 31% MAC. Under these conditions, the extreme forward C. G. occurs at approximately 29.90% MAC.

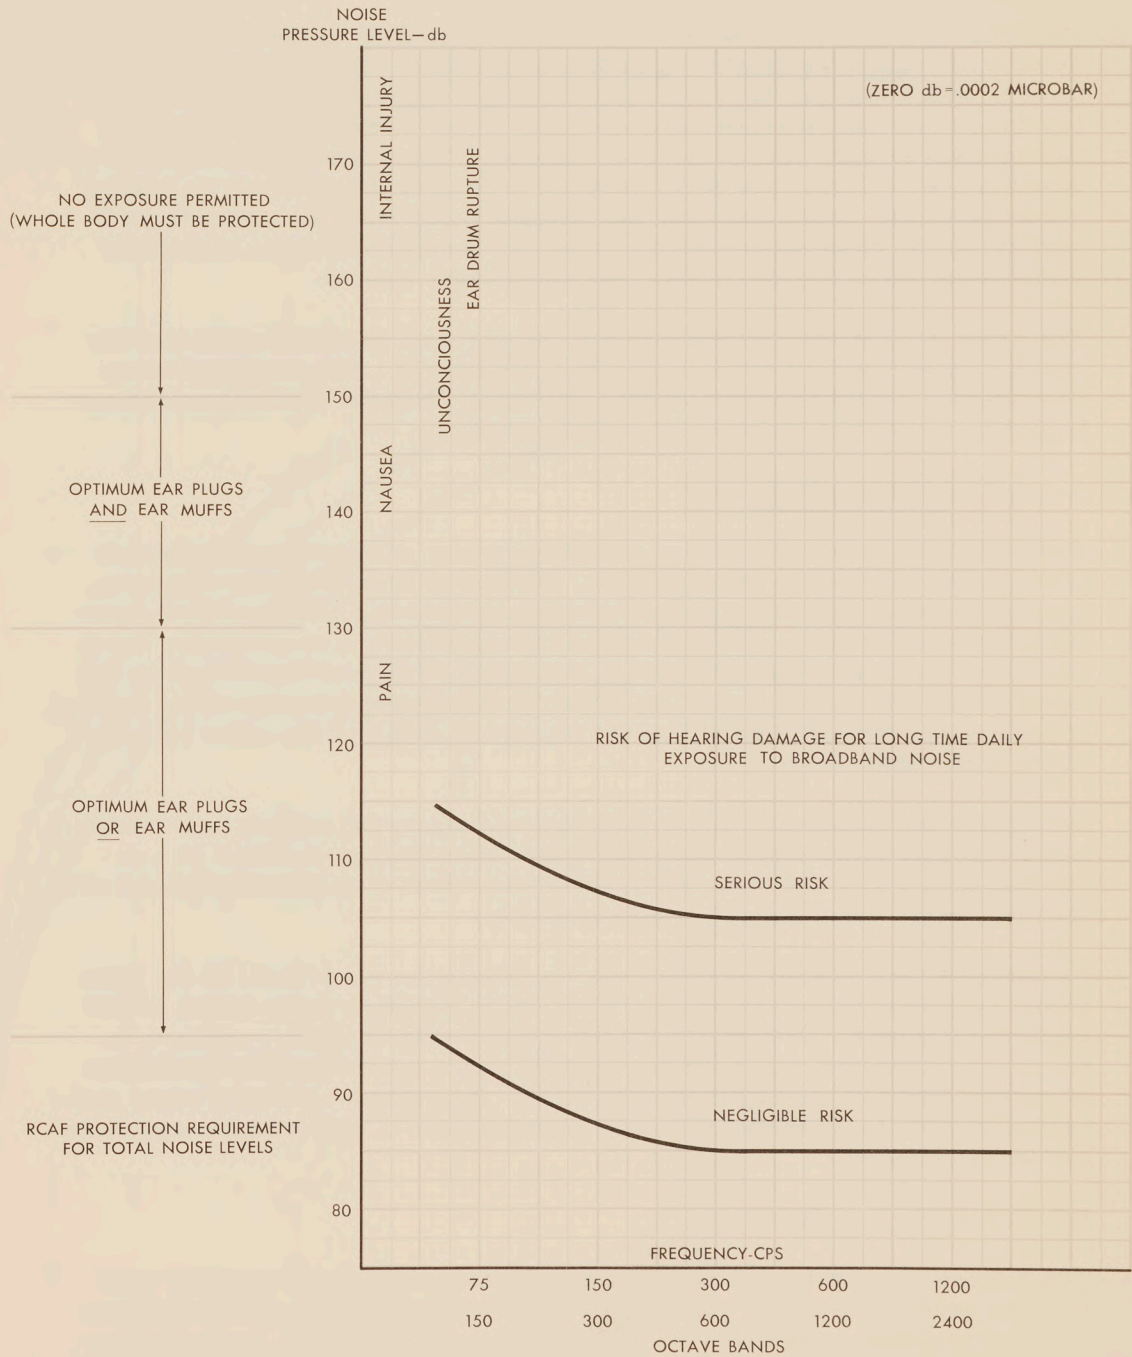
FIG. 10 PHYSIOLOGICAL ASPECTS OF NOISE

Figure 10 shows the estimated results of various sound pressure levels and suggested protection requirements.

Personnel directly exposed for relatively long periods to the ARROW's noise field, will require protection against hearing loss. The maximum sound level to which unprotected personnel should be exposed for long periods is 110 db; no one should repeatedly approach closer to the ARROW than 300 feet in front or 1200 feet to the rear quarter. The present rear cockpit sound pressure levels are being reduced to protect the crew during taxiing and at take-off. After take-off, the internal noise from the engine's jet is negligible; the chief source becomes the air conditioning unit, with some contribution from boundary layer and shock wave effects.

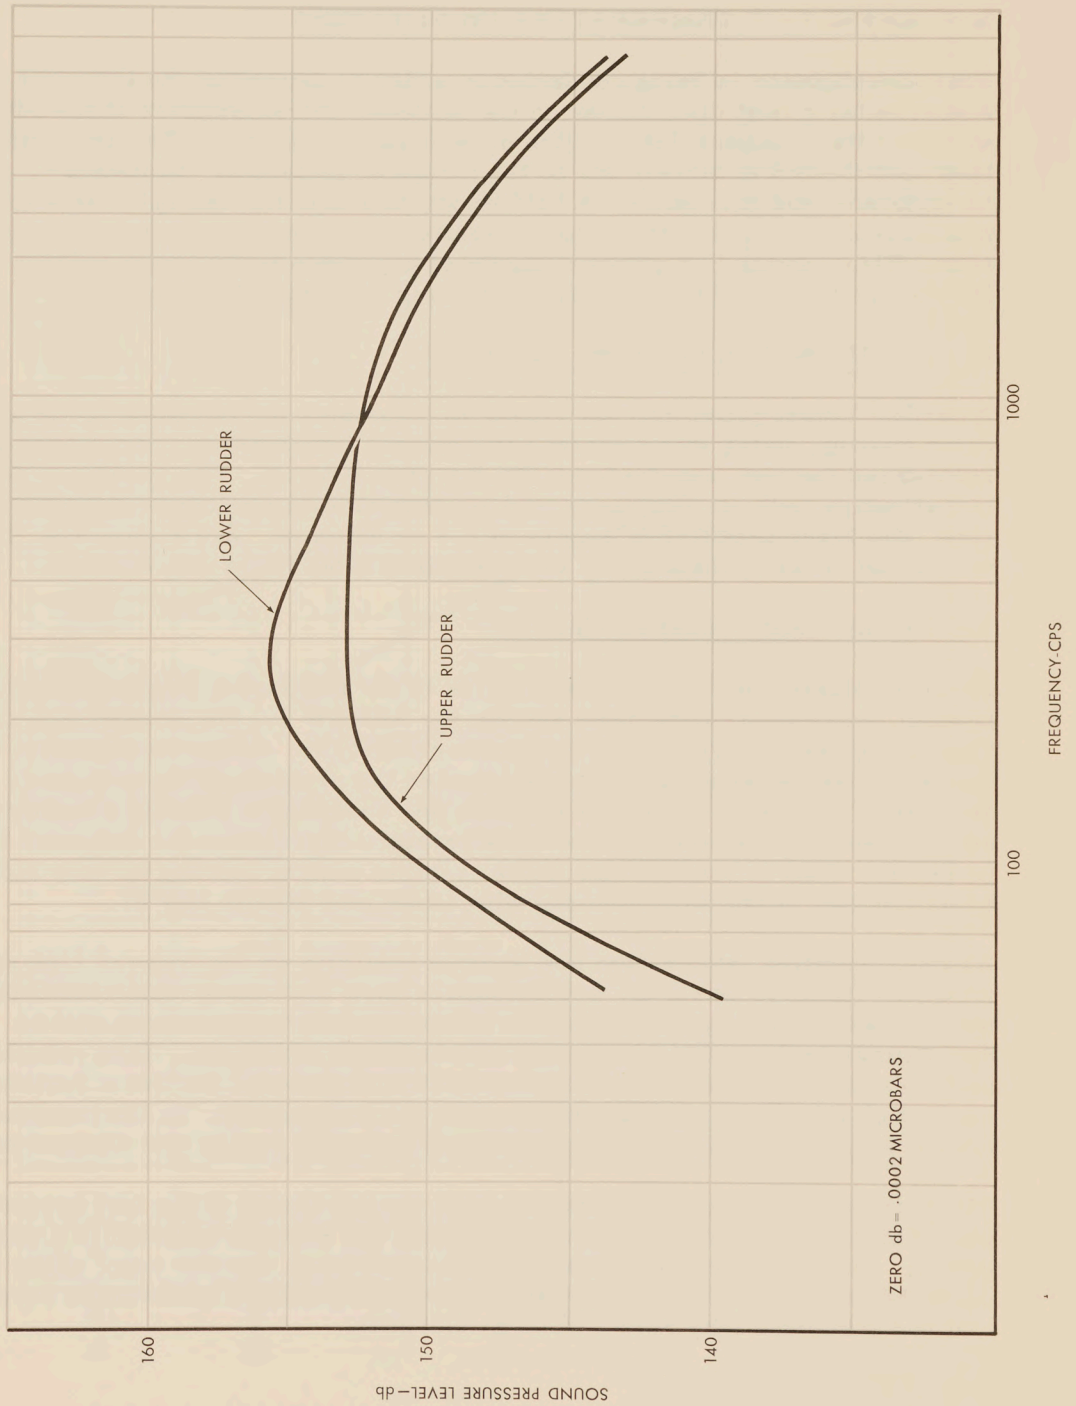
FIG. 12 ARROW RUDDER NOISE LOADING SPECTRA - ONE IROQUOIS 2 WITH AFTERBURNING

Calculations have been made which indicate the fatigue life of various components exposed to the maximum engine jet noise. These components, vibrating at their natural frequencies, have a range of sound pressure levels in which their fatigue life is infinite. Continued exposure above these sound pressure levels leads to deterioration and reduced service life. The frequencies and sound pressure levels for infinite life and for the environment of the component, can be compared to indicate the problem, as illustrated in Figure 12.

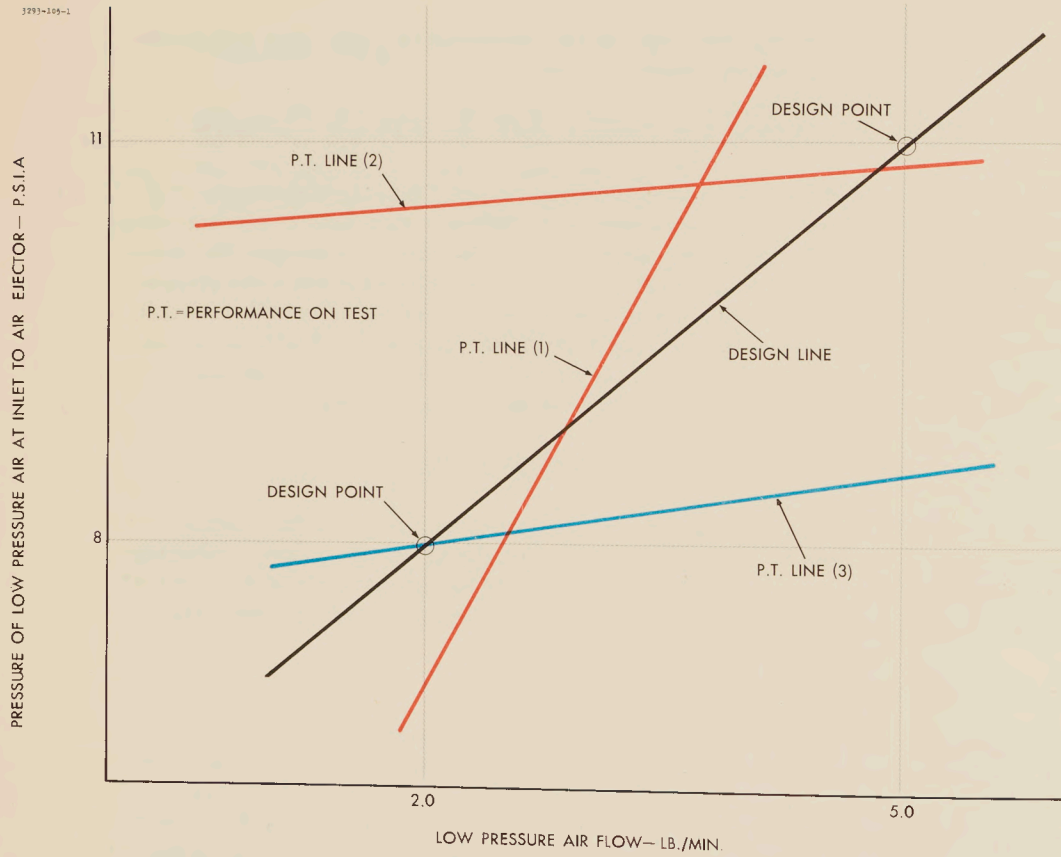
FIG. 28 AIR EJECTOR PERFORMANCE - PRESSURE VS. FLOW FOR LOW PRESSURE AIR

The ejectors now available for installation in ARROW 1 aircraft are performing as shown by test line (1) in Figure 28. Suction attainable with this ejector is low at the higher low pressure air flows. Modification of this ejector has improved performance at high tank pressures but resulted in poorer performance in the low pressure range. This is represented by test line (2) in Figure 28. It is expected that performance corresponding to test line (3) can be achieved by increasing the high pressure air flow in the modified ejector. Such a unit would be satisfactory for ARROW 2 installation.

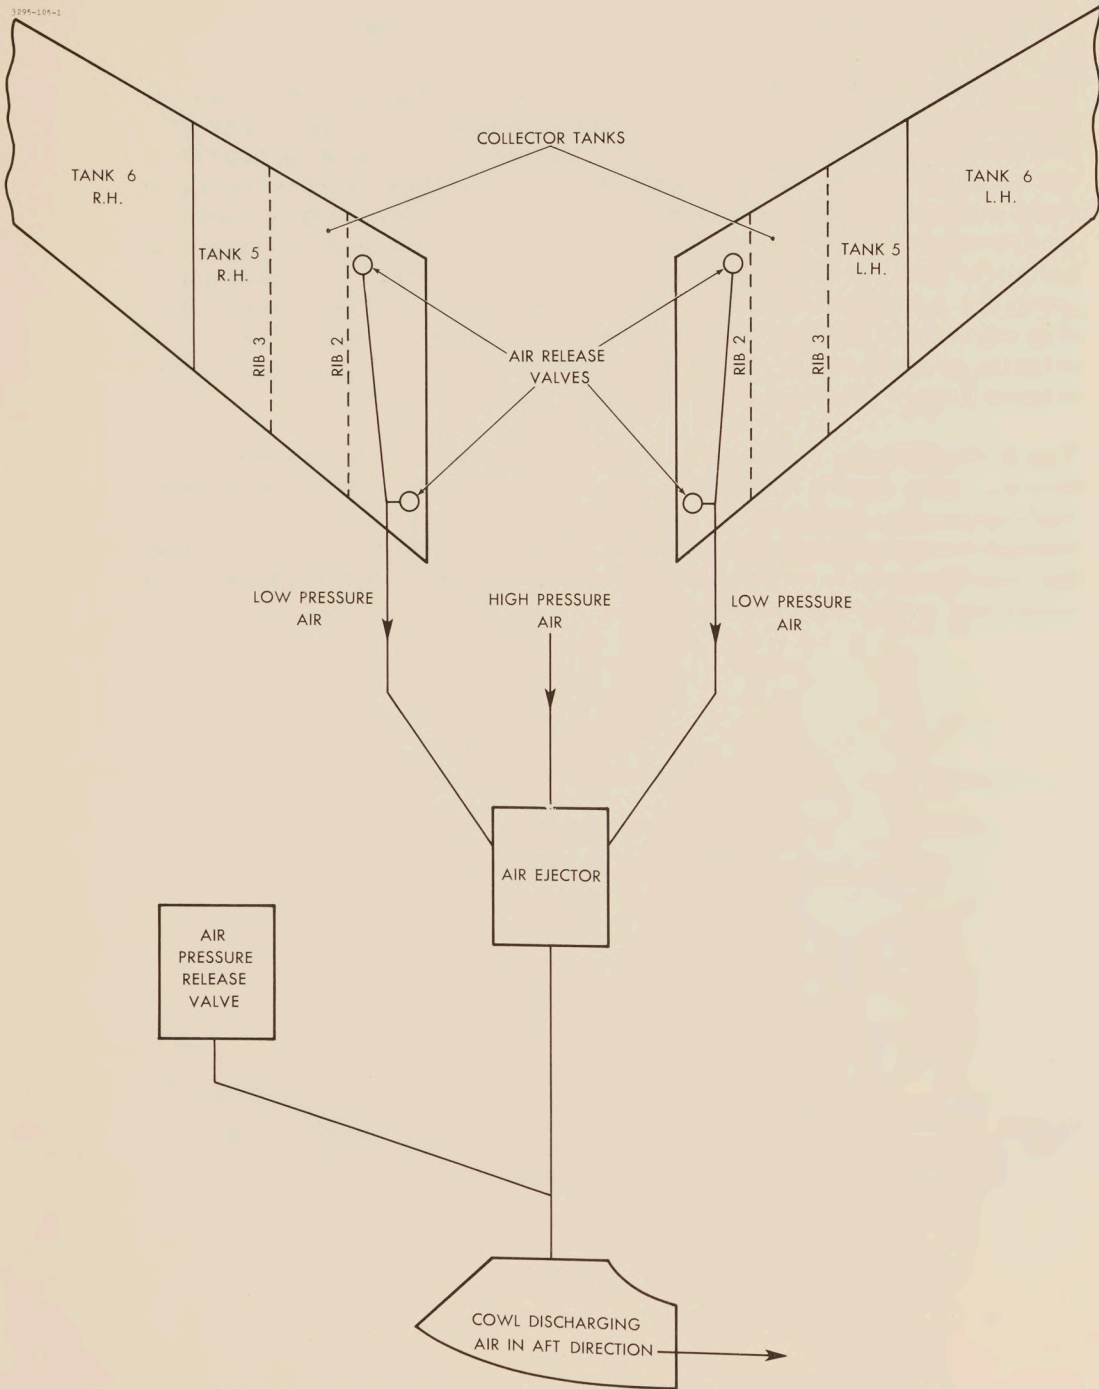
FIG. 30 SIMPLE SCHEMATIC - COLLECTOR TANK AIR RELEASE - ARROW 2

Modification of the collector tank venting system has been necessary to accommodate the increased air release requirements which occur when a tributary tank fuel-no-air valve fails to open. Flow handling capability of the original system was inadequate for this condition because the piping friction head, as determined by pipe sizes and number of pipe bends, restricted air flow. During such an emergency, inadequate release of collector tank air increases collector tank air pressure, eliminating the pressure differential available for fuel transfer. It is considered essential that sufficient transfer capability be retained to allow use of the fuel in the affected system during the return phase of a mission. All pipes to the air ejector Figure 30 have been increased to 1.0 inch diameter.

The aft outboard air release valve has been repositioned inboard of rib No. 2. This makes it effective over a wider range of aircraft attitudes, maintaining the fuel level in the collector tank above the level at which the cockpit warning light is illuminated. The air release valves, as defined by the specification, are capable of adequately handling the larger air flows occurring during the condition noted.
